**Massachusetts Department of Environmental Protection**  
Bureau of Resource Protection – Watershed Permitting Program  
**Sanitary Sewer Overflow (SSO)/Bypass**  
**Notification Form**

Hull, MA WPCF

## Unauthorized Discharge Summary 10 Rockaway Ave [07-30-18]

# 10-12 Rockaway Ave

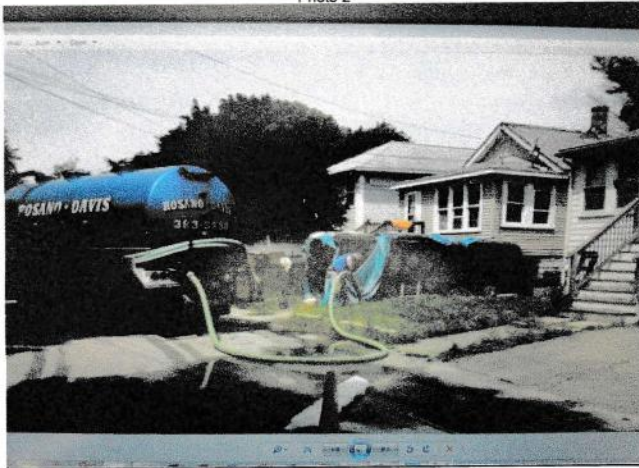
Photo 1

Pump truck service at 10 Rockaway

7. Corrective Actions : Contacted septic pump truck company immediately, Rosano Davis Pumping. The pump chamber was pumped out and cleaned, and new replacement pump installed. The nearby catch basin was also pumped out and cleaned. **NO liquid left the catch basin sump**, as this liquid was vacuumed up and structure cleaned out.

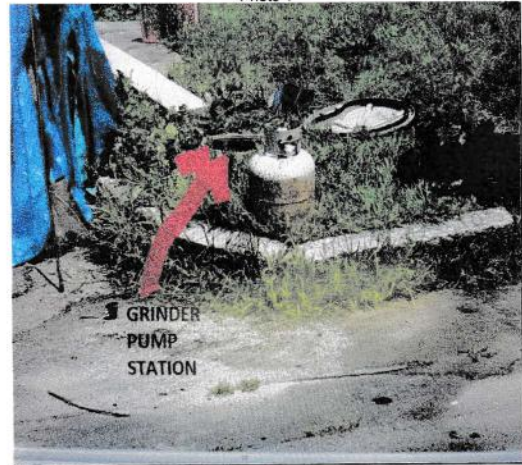
Photo 3

6. Cause of SSO Event: Other - Specify Below  
Rain Event, PS Failure, Insufficient Capacity in System, Treatment Unit failure, Sewer System Blockage, Pipe Collapse, Root Intrusion, Grease Blockage, Other  
Specify: E1 grinder pump failed. Alarm notification from homeowner did not reach the sewer department until SSO occurred on 7/30/18, even though pump system was in alarm. Pump chamber contained a lot of solids, grease, and plastics which most likely contributed to pump failure.

GRINDER  
PUMP  
STATION

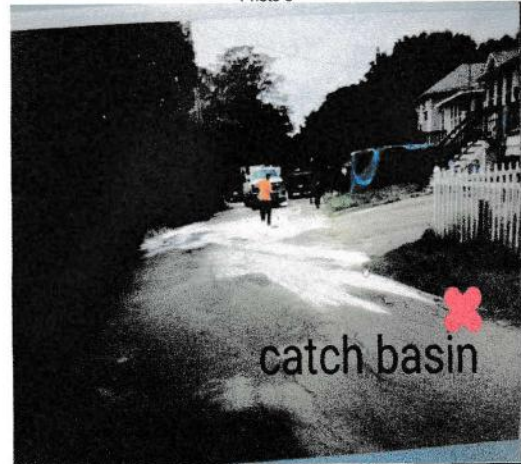
catch basin

down gradient catch basin

If caused by a blockage, identify the type of blockage (e.g., grease, rags, debris);	<i>NA</i>
If caused by a mechanical, electrical, or structural failure, the date of the last inspection, maintenance, or repair of the failed asset;	<i>NA</i>
Did the release reach any portion of the Town's Municipal Separate Storm Sewer System ("MS4").	<i>Release made it to MS4 catch basin, but <u>did not</u> travel any further than this structure.</i>

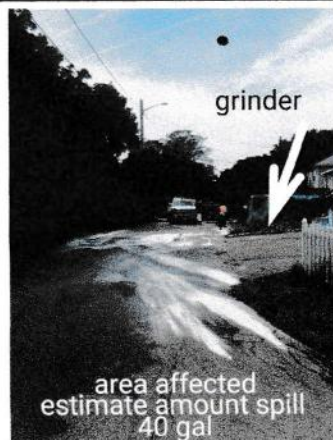
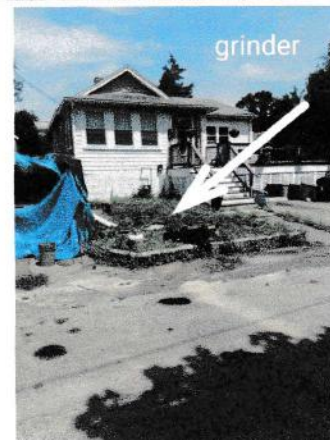
**Service:** Eric Dave on site, Rosano Davis on site due to SSO see details. Rosano pumped entire grinder can which was dirty with grease, rags, plastic shampoo caps. Replaced grinder now operational. Also applied lime on effected area
